The Republic of the Union of Myanmar
Ministry of Transport
Department of Meteorology and Hydrology
Review of the Hydrological Impacts of Myanmar
in 2010 and 2011

Presented
By
Sein Lin
Staff Officer
Department of Meteorology and Hydrology

2-4 April , 2012

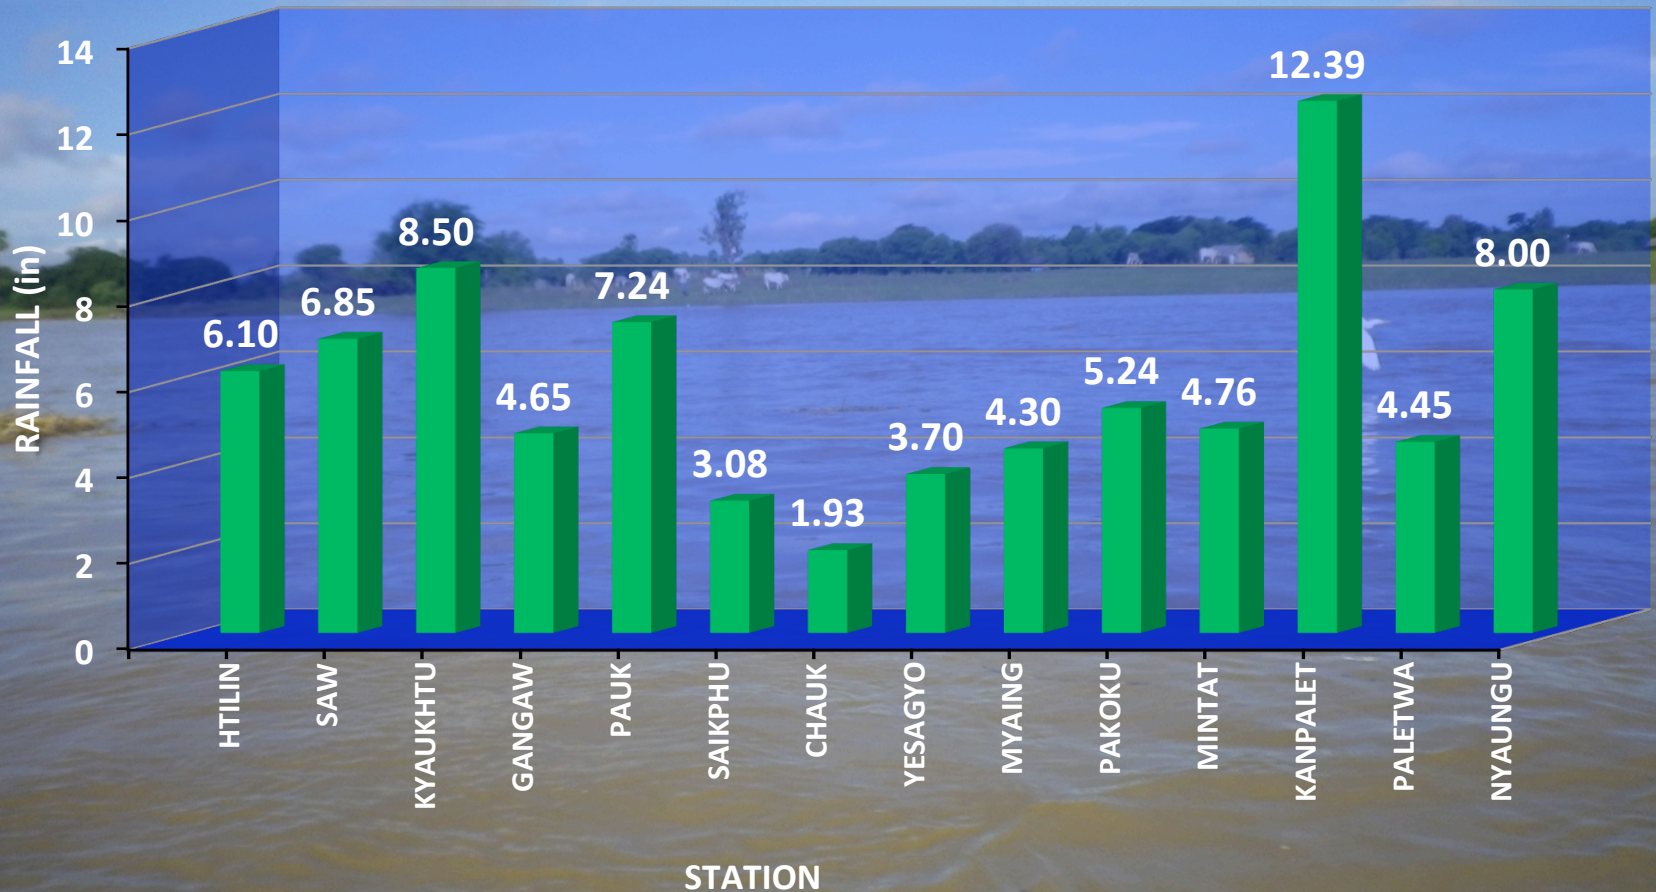
*MAXIMUM RAINFALL OF THE STATIONS IN THE SHWECHAUNG
CATCHMENT AREA
DURING THE PERIOD OF FLASH FLOOD OCCURRANCE (20-10-2011)*

■ Rainfall(in)

The causes of Shwechaung flash flood on 20th October 2011 are as following:-

- **The effect of heavy rainfall**
- **Soil erosion**
- **Topography**
- **Channel storage capacity and**
- **Bank erosion**

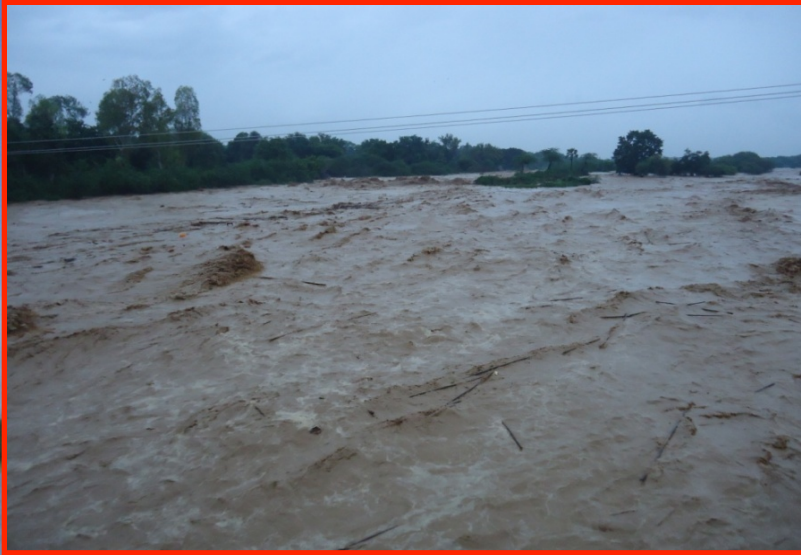
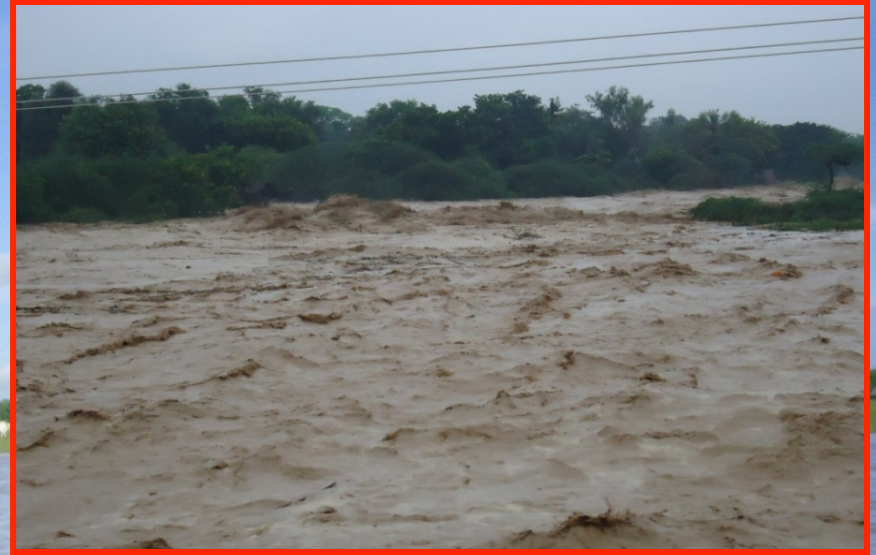
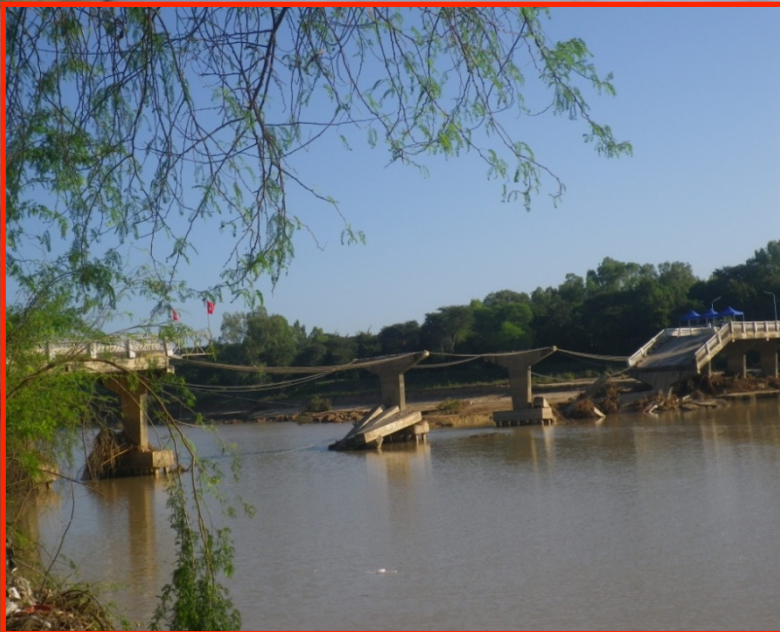
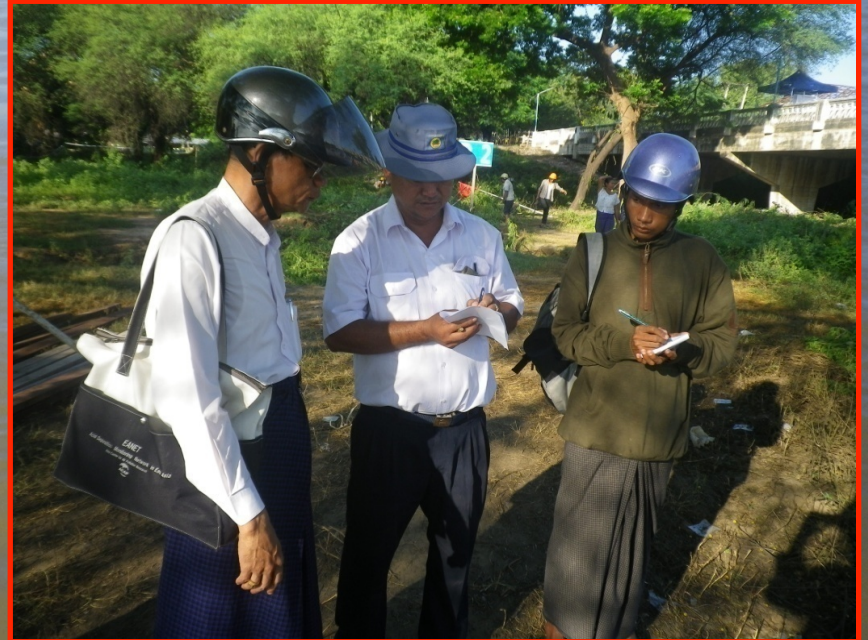
Shwechaung Flash Flood at Pakokku (20-10-2011)

• No. of affected village-tract	=	217
• No. of Kwin	=	365
• No. of farmers	=	6805
• Acre affected	=	8376
• Acre destroyed	=	3253
– Flood	=	1840
– Sand covered	=	752
– Eroded	=	661

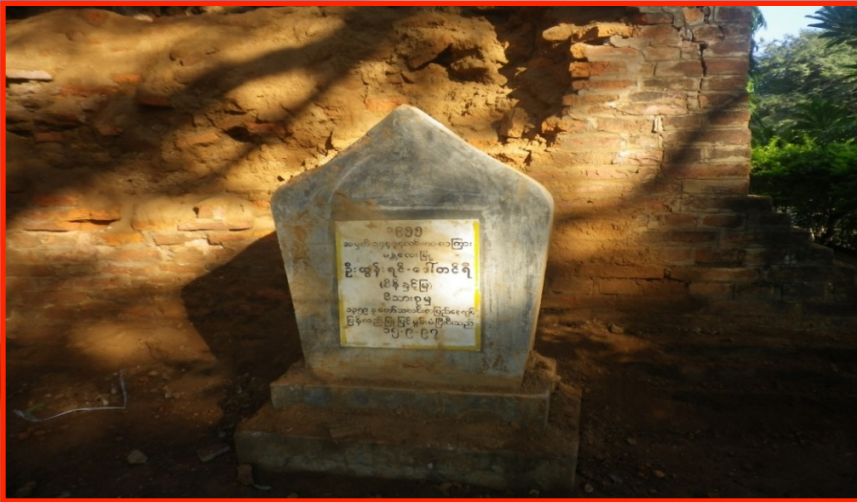
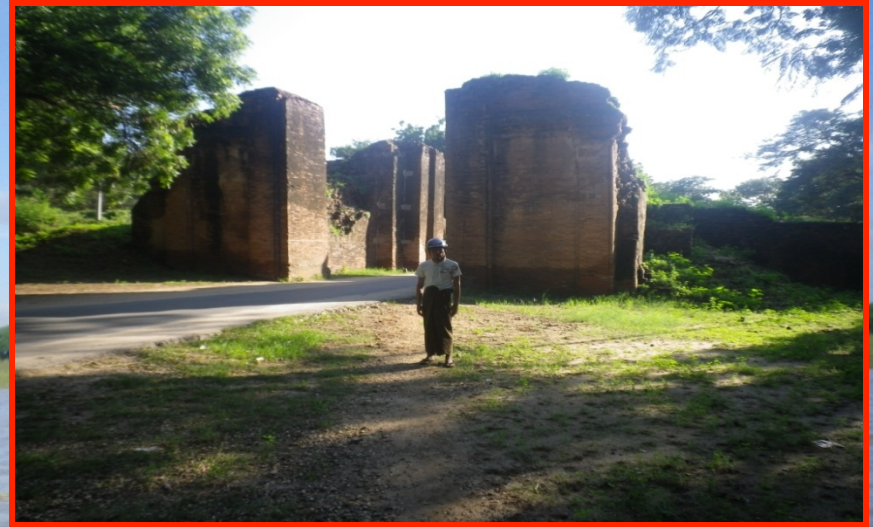
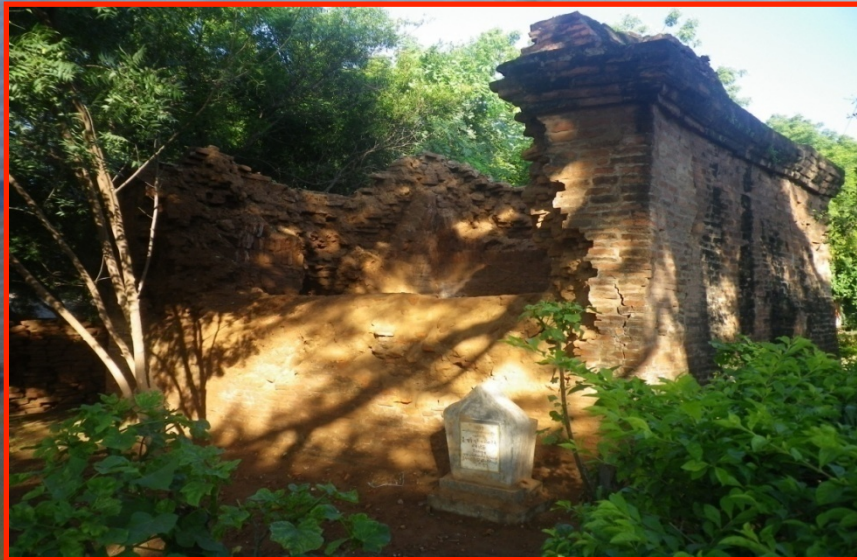
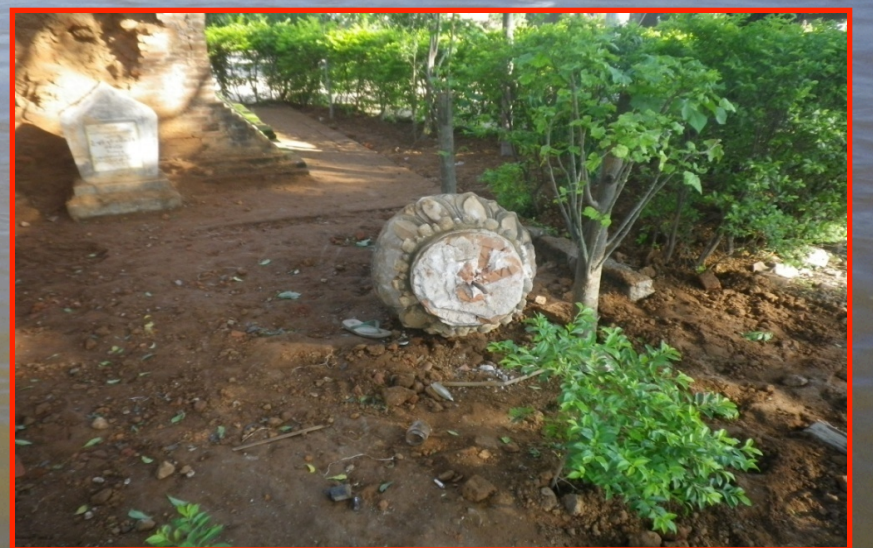
Damages caused by heavy Rainfall at Nyaung U and Bagan (20.10.2011)
